## Lead-Based Paint Risk Assessment Report

762 Schoharie Hill Road  
Schoharie, New York

20-25699-L

June 26, 2020

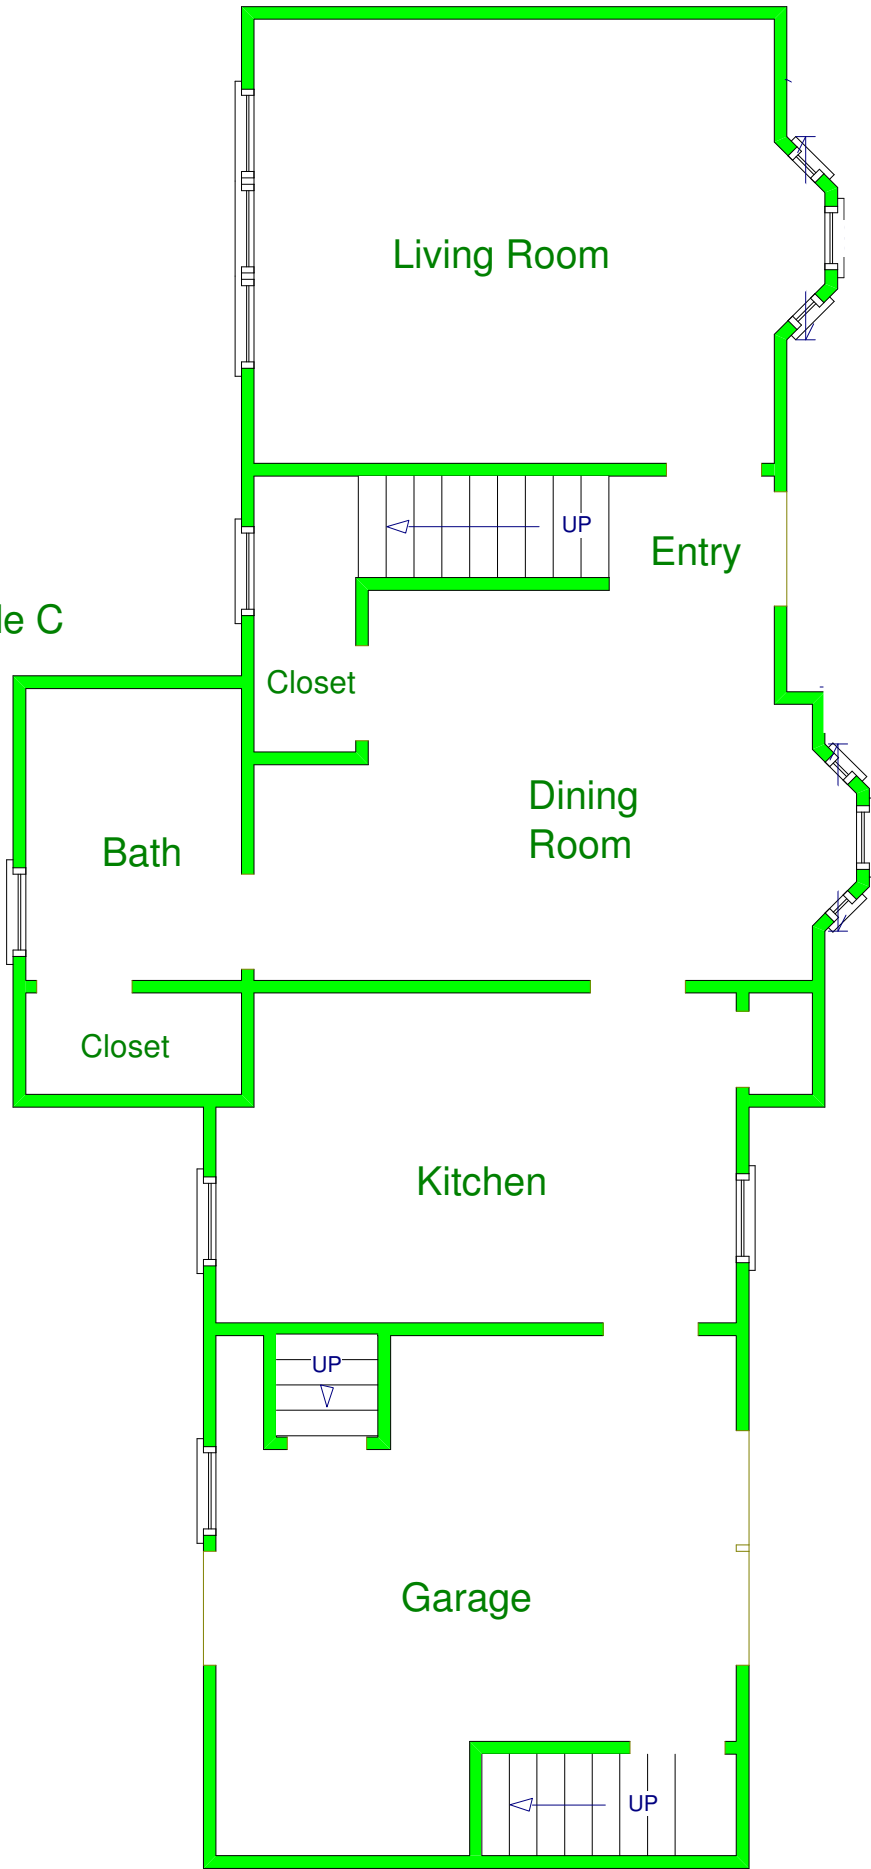
762 Schoharie Hill Road  
Schoharie, New York  
1st Floor

Location	Lead Painted Component(s)	Condition	Lead Hazard	Notes
Entry	Stair Baseboard	Intact	Yes	Friction/impact surface
Dining Room	Closet Floor	Intact	Yes	Friction/impact surface
	Closet Window Sash	Intact	No	Intact, rare use
1 <sup>st</sup> Floor Bath	Door jambs	Intact	Yes	Friction/impact surface
	Closet Baseboard	Peeling	Yes	Peeling
Garage	Doors	Peeling	Yes	Peeling, Friction/impact surface
	Wood Walls	Intact	No	Intact
	Window Sashes	Peeling	Yes	Friction/impact surface
Room 200	Window Sashes	Intact	Yes	Friction/impact surface, dust
	Window Sills	Intact	Yes	Friction/impact surface, dust
2 <sup>nd</sup> Floor Hall	Floor	Intact	Yes	Friction/Impact Surface, dust
	Door & jambs	Peeling	Yes	Peeling, friction/impact surface
	Window Sashes	Peeling	Yes	Peeling, friction/impact surface
Room 201	Window Sashes	Peeling	Yes	Peeling, friction/impact surface, dust
	Baseboards	Peeling	Yes	Peeling, poor condition
	Doorjambs	Intact	Yes	Friction/impact surface

Location	Lead Painted Component(s)	Condition	Lead Hazard	Notes	Suggested Interim Control Option	Amount*
Entry	Stair Baseboards	Intact	No	Intact	1. Ongoing monitoring/maintenance.	N/A
Dining Room	Closet Floor	Intact	Yes	Friction/impact surface	1. Cover with carpet or vinyl flooring (optional). 2. Ongoing monitoring/maintenance.	>6ft <sup>2</sup>
	Closet Window Sashes	Intact	No	Intact, rare use	1. Ongoing monitoring/maintenance.	1 Window
1 <sup>st</sup> Floor Bath	Door Jambs	Intact	Yes	Friction/impact surface	1. Remove/replace door stops. 2. Plane door so doesn't touch jambs. 3. Ongoing monitoring/maintenance.	2 Doorways
	Closet Baseboards	Peeling	Yes	Peeling	1. Paint stabilization. 2. Remove/replace baseboards (optional). 3. Ongoing monitoring/maintenance.	>2ft <sup>2</sup>
Garage	Doors	Peeling	Yes	Friction/impact surface	1. Paint stabilization. 2. Remove/replace doors (optional). 3. Ongoing monitoring/maintenance.	3 Doorways

Wood Walls	Intact	No	Intact	1. Ongoing monitoring/maintenance.	N/A
	Window Sashes	Peeling	Yes	Friction/impact surface	1. Paint stabilization. 2. Remove/replace window (optional).	1 Window
Room 200	Window Sashes	Intact	Yes	Friction/impact surface, dust	1. Dust clean up. 2. Same as Garage	4 Windows
	Window Sills	Intact	Yes	Dust	1. Dust cleanup. 2. Ongoing monitoring/maintenance. 3. Remove/replace sills (optional).	4 Windows

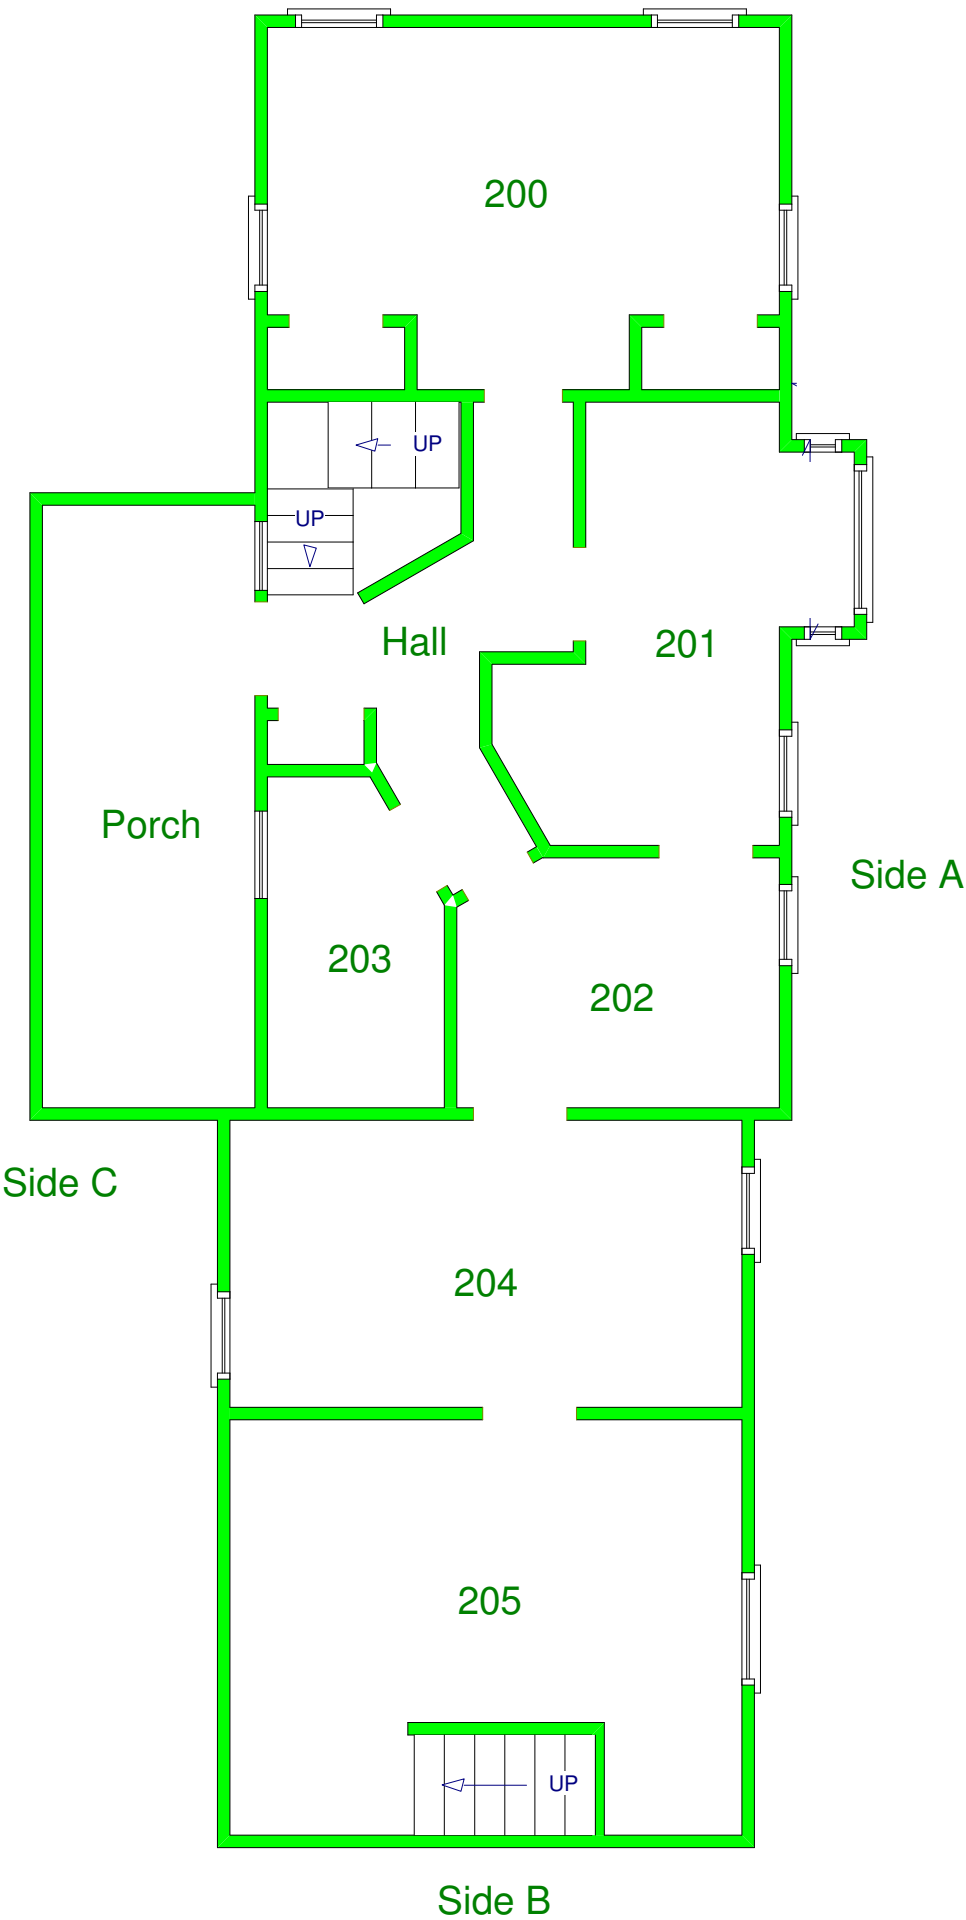
762 Schoharie Hill Road  
Schoharie, New York  
2nd Floor

Room 202	Window Sashes	Peeling	Yes	Peeling, friction/impact surface
	Window Sills	Peeling	Yes	Peeling
	Door Threshold	Peeling	Yes	Peeling, friction/impact surface
Room 203	Plaster Walls	Intact	No	Intact
	Baseboards	Intact	No	Intact
	Window Sashes	Peeling	Yes	Peeling, friction/impact surface

Location	Lead Painted Component(s)	Condition	Lead Hazard	Notes
2 <sup>nd</sup> Floor Porch	Railing	Peeling	Yes	Peeling
Room 204	Window Sashes	Intact	Yes	Friction/impact surface
	Plaster Walls	Peeling	Yes	Peeling
	Doors	Peeling	Yes	Peeling
Room 205	Window Sashes	Peeling	Yes	Peeling, friction/impact surface
Exterior	Siding	Peeling	Yes	Peeling
	Porch Columns	Peeling	Yes	Peeling
	Garage Door Trim	Peeling	Yes	Peeling
	Doorjambs	Peeling	Yes	Peeling

Location	Lead Painted Component(s)	Condition	Lead Hazard	Notes	Suggested Interim Control Option	Amount*
2 <sup>nd</sup> Floor Hall	Floor	Intact	Yes	Friction/impact surface, dust	1. Dust cleanup. 2. Same as Dining Room.	>6ft <sup>2</sup>
	Door & Jambs	Peeling	Yes	Peeling, friction/impact surface	1. Paint stabilization. 2. Ongoing monitoring/maintenance. 3. Remove/replace door & jambs (optional)	6 Doorways
	Window Sashes	Peeling	Yes	Peeling, friction/impact surface	1. Same as Garage	1 Window
Room 201	Window Sashes	Peeling	Yes	Peeling, friction/impact surface, dust	1. Same as Garage	3 Windows
	Baseboards	Peeling	Yes	Peeling, poor condition	1. Same as 1 <sup>st</sup> Floor Bath	>6ft <sup>2</sup>
	Doorjambs	Intact	Yes	Friction/impact surface	1. Same as 1 <sup>st</sup> Floor Bath	2 Doorways
Room 202	Window Sashes	Peeling	Yes	Peeling, friction/impact surface	1. Same as Garage	1 Window
	Window Sill	Peeling	Yes	Peeling	1. Same as Room 200	1 Window

Door Threshold	Peeling	Yes	Peeling	1. Remove/replace door threshold. 2. Ongoing monitoring/maintenance.	<2ft <sup>2</sup>
Room 203	Plaster Walls	Intact	No	Intact	1. Ongoing monitoring/maintenance.	N/A
	Baseboards	Intact	No	Intact	1. Ongoing monitoring/maintenance.	N/A
	Window Sashes	Peeling	Yes	Peeling, friction/impact surface	1. Same as Garage	1 Window

Location	Lead Painted Component(s)	Condition	Lead Hazard	Notes	Suggested Interim Control Option	Amount*
2 <sup>nd</sup> Floor Porch	Railing	Peeling	Yes	Peeling	1. Paint stabilization. 2. Ongoing monitoring/maintenance.	<20ft <sup>2</sup>
Room 204	Window Sashes	Intact	Yes	Friction/ impact surface	1. Same as Garage.	2 Windows
	Walls	Peeling	Yes	Peeling	1. Paint stabilization. 2. Cover with drywall (optional).	>6ft <sup>2</sup>
	Doors	Peeling	Yes	Peeling, friction/ impact surface	1. Same as Garage	2 Doorways
Room 205	Window Sashes	Peeling	Yes	Peeling, friction/ impact surface	1. Same as Garage	1 Window
Exterior	Siding	Peeling	Yes	Peeling	1. Paint stabilization. 2. Remove/replace siding (optional). 3. Ongoing monitoring maintenance.	>20ft <sup>2</sup>
	Porch Columns	Peeling	Yes	Peeling	1. Paint stabilization. 2. Ongoing monitoring/maintenance.	<20ft <sup>2</sup>
	Garage Door Trim	Peeling	Yes	Peeling	1. Paint stabilization. 2. Ongoing monitoring/maintenance.	<20ft <sup>2</sup>
