## Lead-Based Paint Risk Assessment Report

102 Fort Stanwix Park North  
Rome, New York

18-23692-A

January 11, 2019

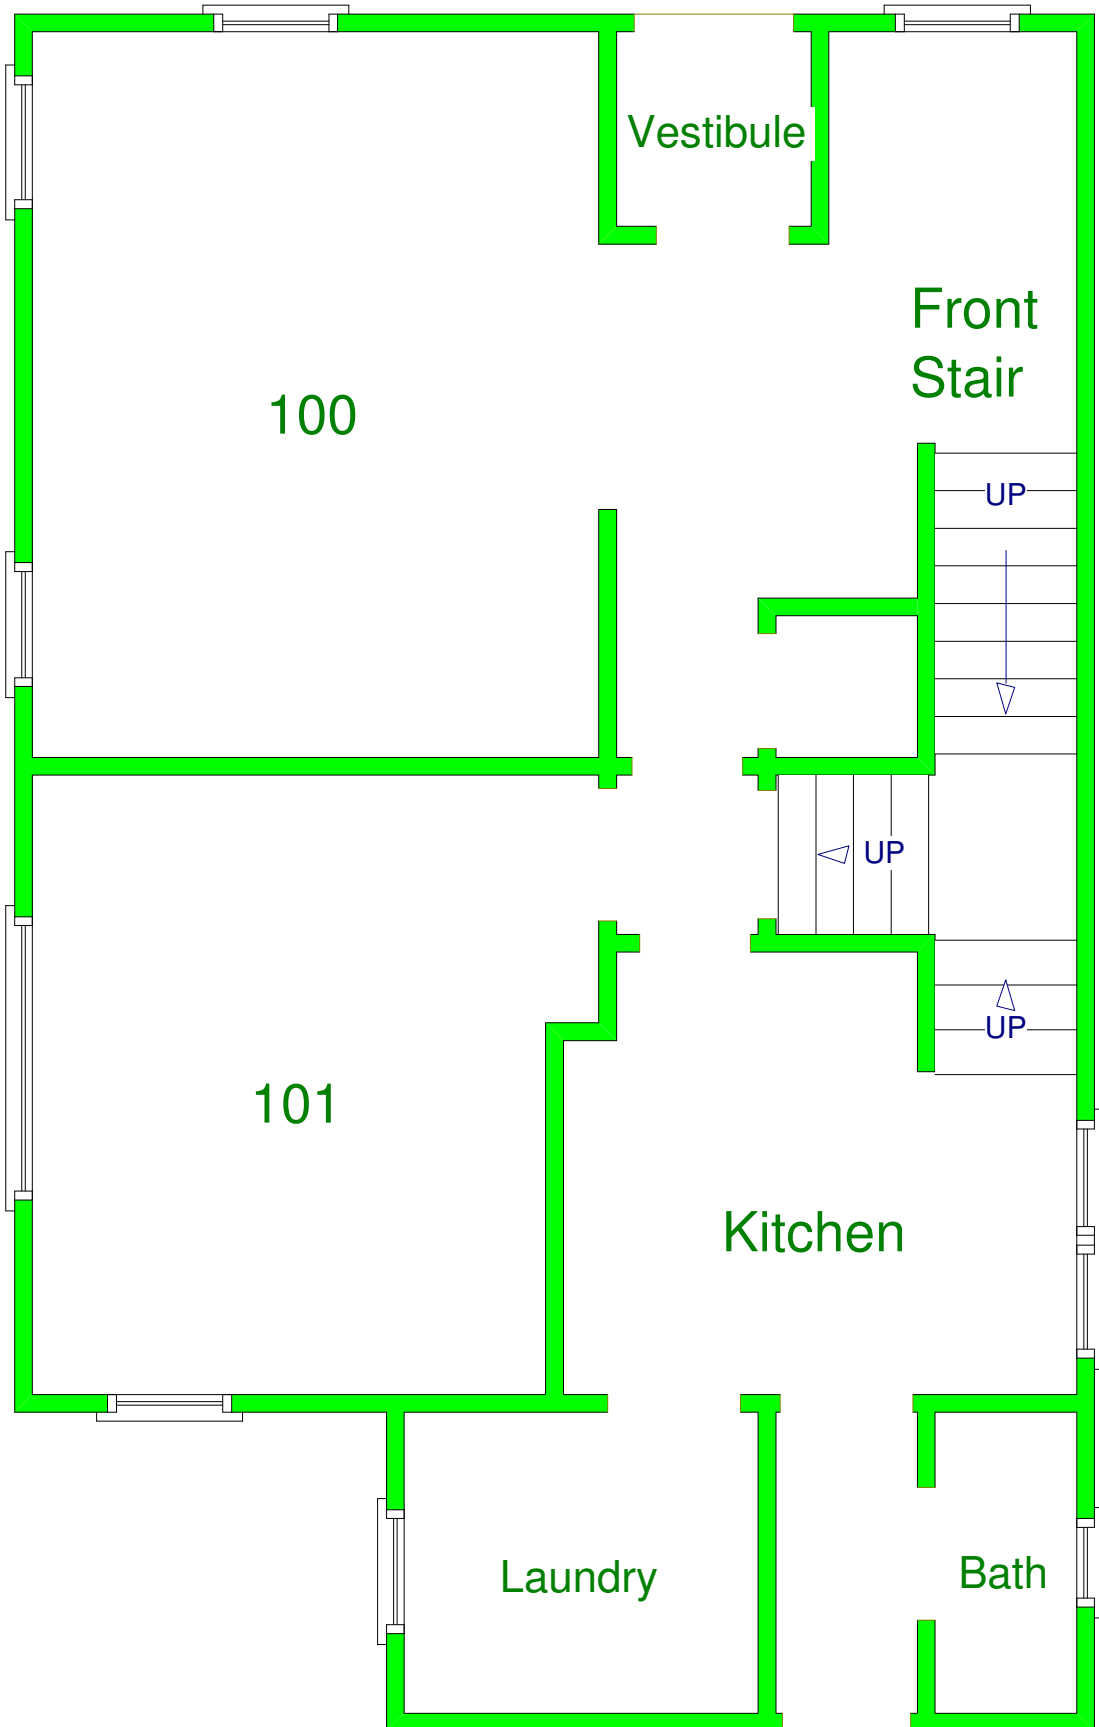
102 Fort Stanwix Park North  
Rome, New York  
1st Floor

Location	Lead Painted Component(s)	Condition	Lead Hazard	Notes
Kitchen	Plaster Walls	Peeling	Yes	Peeling, poor condition
Laundry	Plaster Wall	Cracked	Yes	Cracked
1 <sup>st</sup> Floor Bath	Plaster Walls	Intact	No	Intact
Exterior	Doorjams	Peeling	Yes	Peeling, poor condition
	Columns	Peeling	Yes	Peeling, poor condition
	Corner Board Trim	Peeling	Yes	Peeling, poor condition
	Window Sashes	Peeling	Yes	Peeling, poor condition

Sample #	Location	Lead Concentration ( $\mu\text{g}/\text{ft}^2$ )	Lead Hazard
1	Kitchen Floor	400	Yes
2	Entry Floor	700	Yes
3	Room 201 Window Sill	3,500	Yes
4	Room 202 Window Sill	2,400	Yes
5	Location A (Field Blank)	<10	N/A

It is recommended that any lead-based paint (LBP) be removed from friction or impact surfaces (stairs, windows, etc.) prior to reoccupancy by the tenants. If LBP is to remain, it shall be kept in an intact state and/or covered with an impermeable layer (vinyl, aluminum, etc.).
